PROBLEMS, CAUSES, AND CURES

Technical Publication No. C200 • Revised © 2018 | 3rd Edition

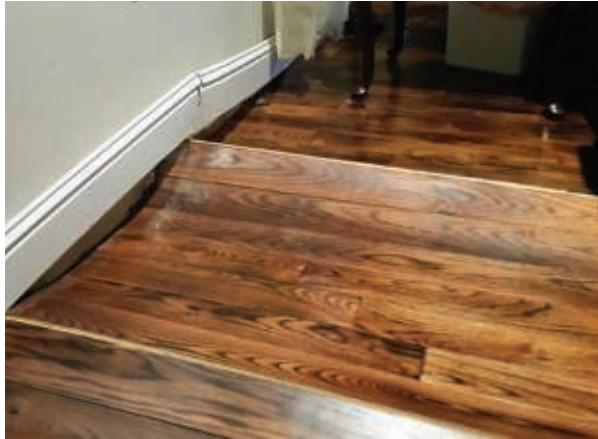
DEFINITION: The wood flooring has separated or lifted from the subfloor.

CAUSES:

- An increase in moisture conditions. Potential sources of moisture may include:
 - Inadequate or inoperable HVAC systems resulting in elevated humidity levels. (See Greenhouse Effect.)

- Wet subflooring (wood or concrete slab).
 - Inadequate moisture control systems installed beneath the wood floor.
 - Poor building drainage resulting in rainwater runoff or subsurface groundwater.

- Moisture from inadequately ventilated or unconditioned crawl spaces or basements.
 - Portable water sources/appliances, building leaks, or plumbing leaks.

- Identify and eliminate the source of moisture. In some cases this will require the use of dehumidification systems to stabilize the ambient conditions and bring them to within the acceptable target range.
- Flooring and subflooring must be allowed to dry to what would be considered "normal levels" for the area before any repairs take place.
- Maintain the environment within the flooring manufacturer's requirements. When conditions are not specified by the manufacturer, maintain temperature between 60°-80°F (15.6°-26.7°C), and relative humidity between 30%-50%.
- Release stress on the floor by providing relief at vertical obstructions.
- Removal and replacement of the affected area is often necessary.

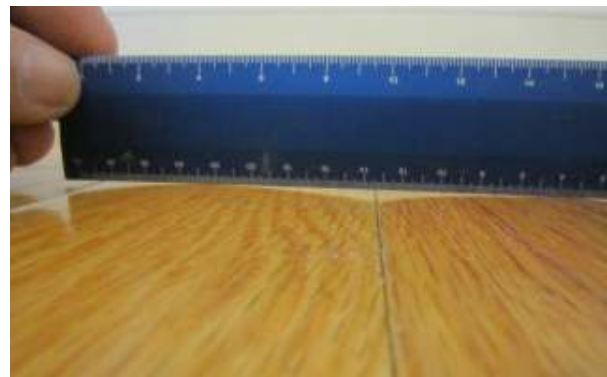
DEFINITION: A convex or crowned appearance of individual boards with the center of the board higher than the edges. This can also be a type of warp.

CAUSES:

- Wood is an anisotropic material, meaning it will shrink/swell in relation to its grain orientation. The extent to which solid wood shrinks or swells is also directly proportional to its width. With an installed solid wide plank plainsawn material, it is not uncommon to see the top of a board shrink or swell more or less than the underside of the board when seasonal conditions change, which may result in a slight crowned or cupped appearance.

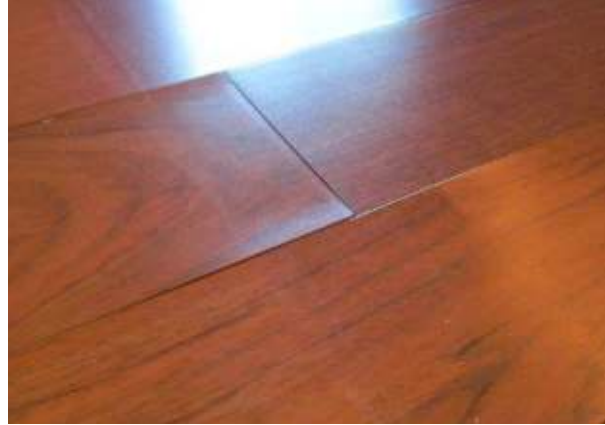
DEFINITION: A concave or dished appearance of individual engineered flooring planks with the edges raised higher than the center.

CAUSES:

- When relative humidity levels remain below the manufacturer's recommendations for long enough, engineered planks can begin to dry cup. When this happens, the wear layer loses moisture and begins to shrink across its outer face, which can exert enough force on the core material to pull the edges of the plank (often the groove side) upward. This causes a cupped appearance across the width of the board.

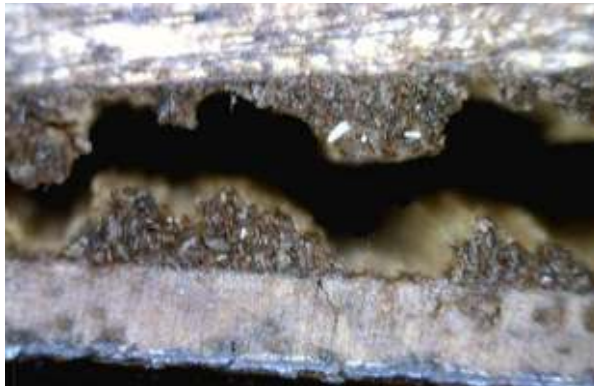
DEFINITION: External stresses exceeding the strength of the wood fibers within an individual plank of engineered flooring, resulting in the wood fibers being torn apart. When examining this type of failure in an engineered wood flooring plank, wood fibers will be visible at the point of separation, remaining bonded to the adhesive layer.

CAUSES:

- Layers within the plank shrink or swell excessively because of low relative humidity or excessive moisture (outside of manufacturer's recommendations), thereby creating excessive force on opposing layers sufficient enough to tear the wood fibers apart.
- Inadequate or inoperable HVAC systems resulting in elevated humidity levels. (See Greenhouse Effect.)

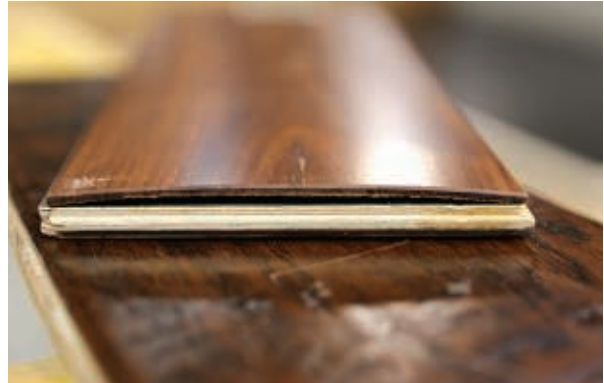
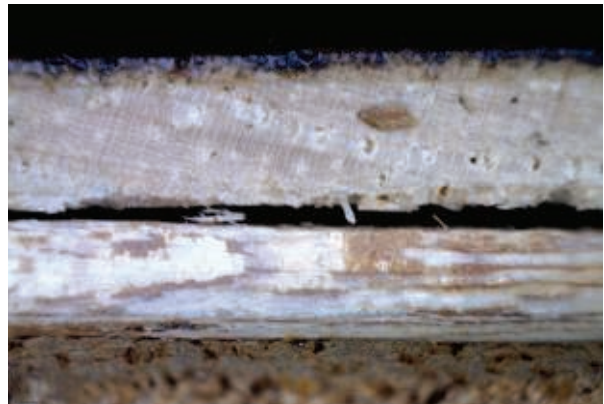
DEFINITION: Engineered flooring is manufactured by adhering several layers/plies together. The separation of two layers/plies within a piece of engineered flooring due to the lack of an adhesive bond is typically identified as a clean separation at the glue-line. Adhesive bond failure is unrelated to inadequate relative humidity levels.

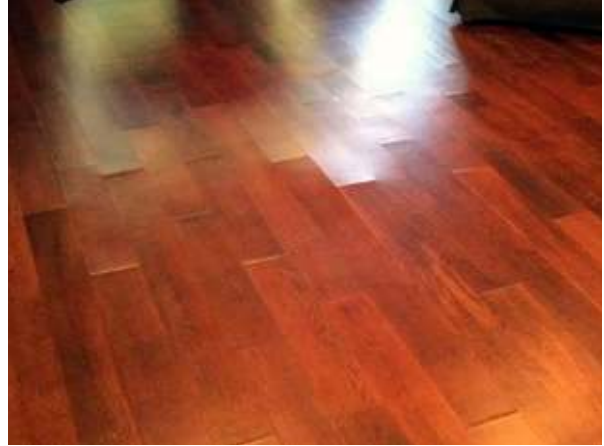
DEFINITION: A condition where the ends of installed engineered wood flooring boards deviate from the flat plane and appear raised or curved upward.

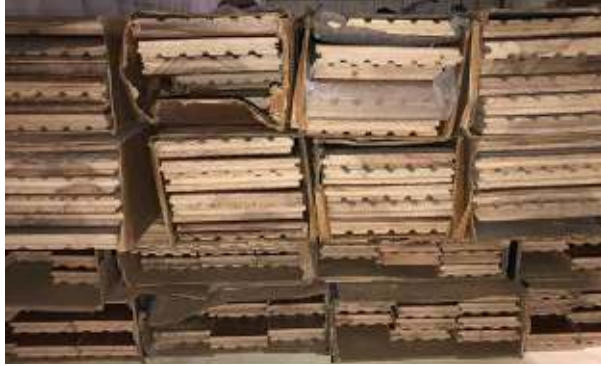
DEFINITION: A condition where the ends of solid wood flooring boards deviate from the flat plane and/or parallel plane, and may appear wider or thicker than the rest of the board.

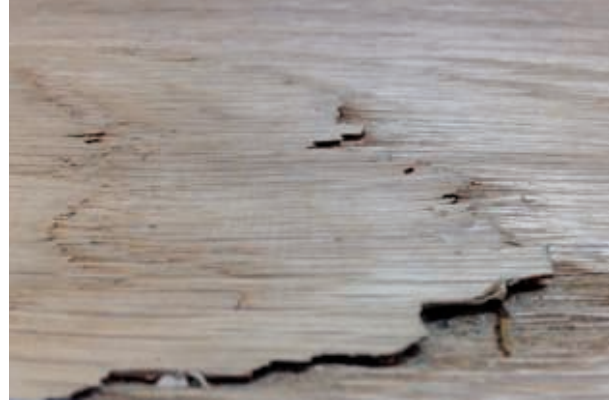
DEFINITION: A separation of the wood's fibers along the grain (parallel to the growth rings), that usually occurs between the rings of annual growth.

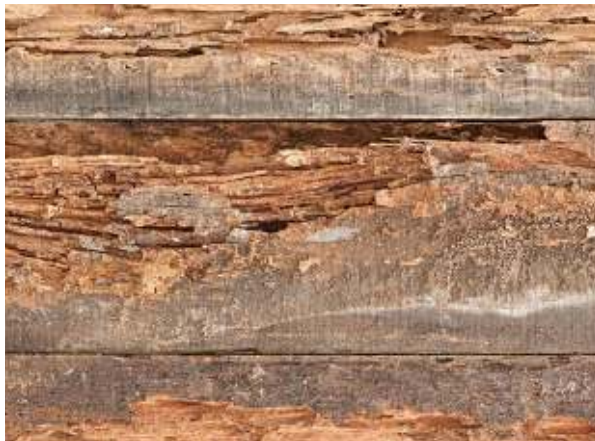
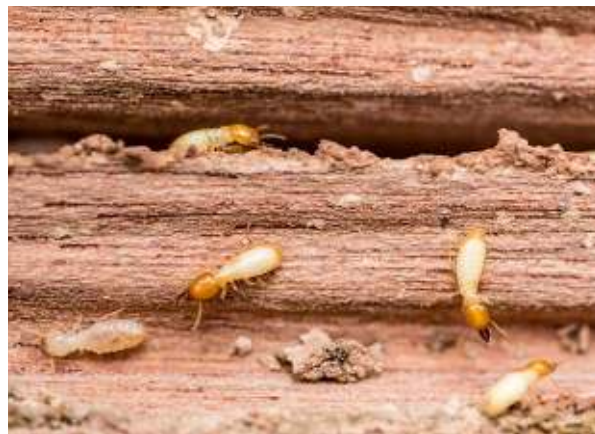
- **Termites** - Termites are attracted to areas where moisture accumulates in and around your home, including damp basements, laundry rooms, bathrooms, and leaky foundation walls.
 - Termites will eat any kind of wood including mulch, rotting wood, new wood, painted wood, and treated wood.
 - Stagnant, moist air in the home provides the perfect breeding ground for termites.
 - Termite-damaged wood is usually hollowed out along the grain, with bits of dried mud or soil lining the feeding galleries. Wood damaged by moisture or other types of insects will not have this appearance.
 - Termite infestations are a site-specific condition.

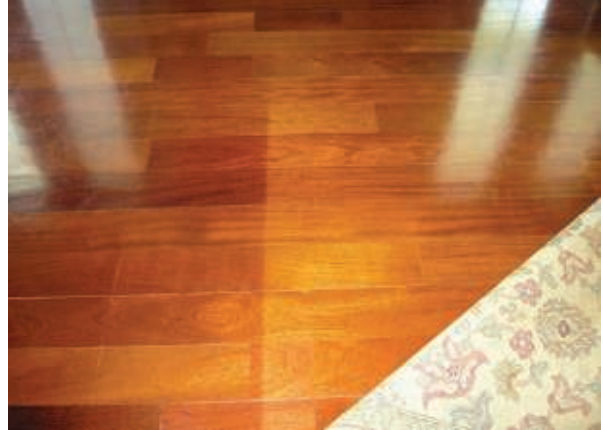
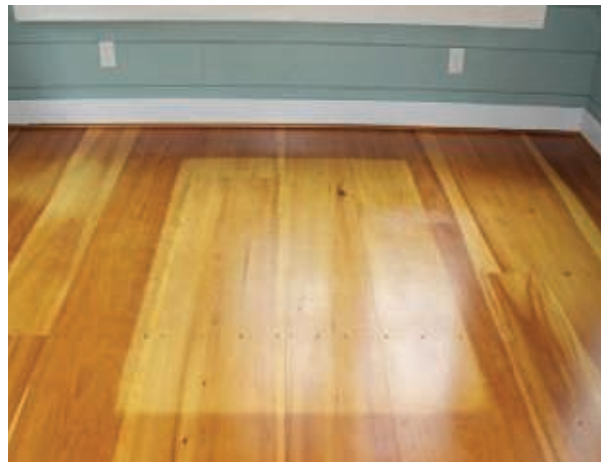
DEFINITION: The wood itself changes color over time (darkens or lightens).

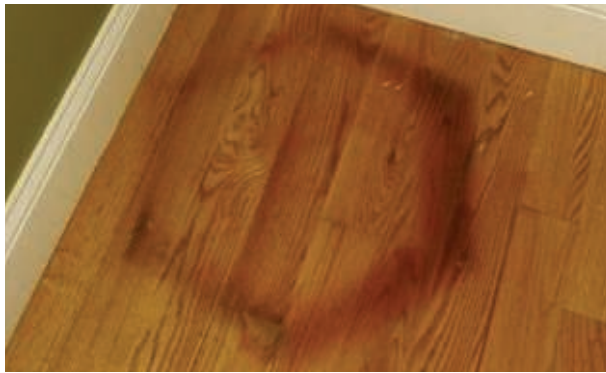
DEFINITION: The wood or finish changes color with exposure to moisture.

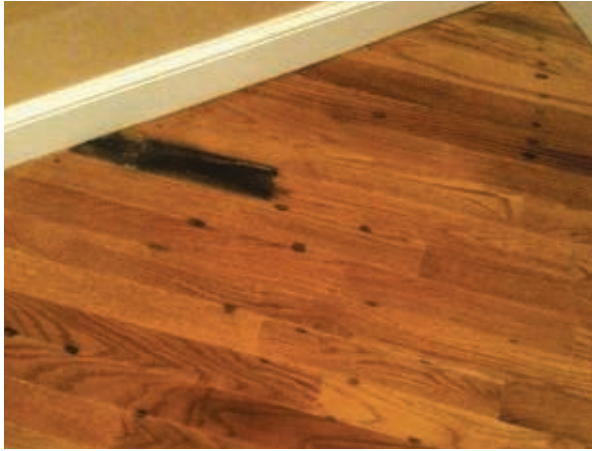
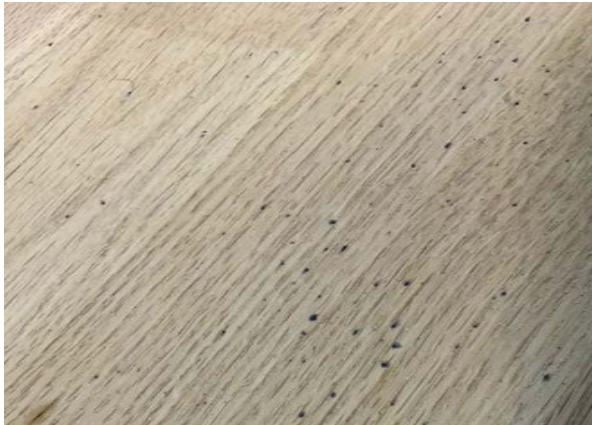
DEFINITION: A result of a chemical reaction between wood tannins, water, and iron.

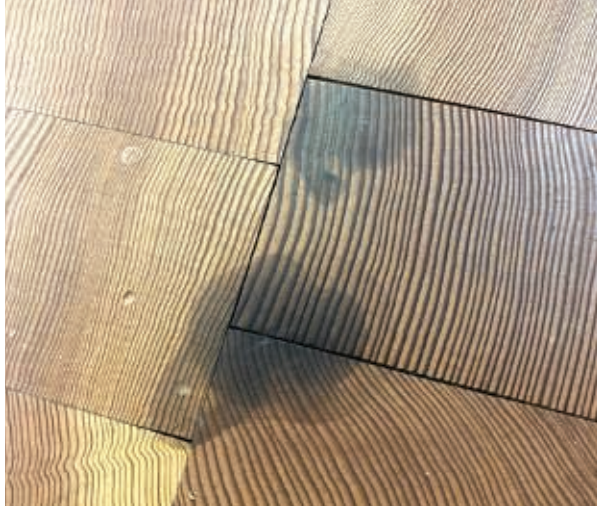
DEFINITION: Irregular shaped spots or discolorations on areas of the finished floor caused by reactive chemicals and/or air pollution.

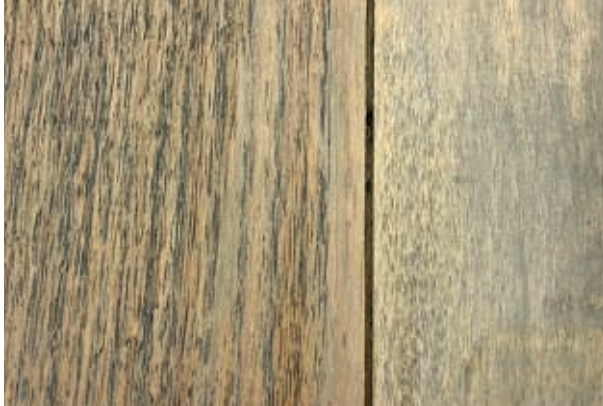
DEFINITION: Gaps that appear between individual boards, opening and closing with seasonal humidity changes. Wider boards can experience wider gaps. Gap size is directly related and proportional to the board width.

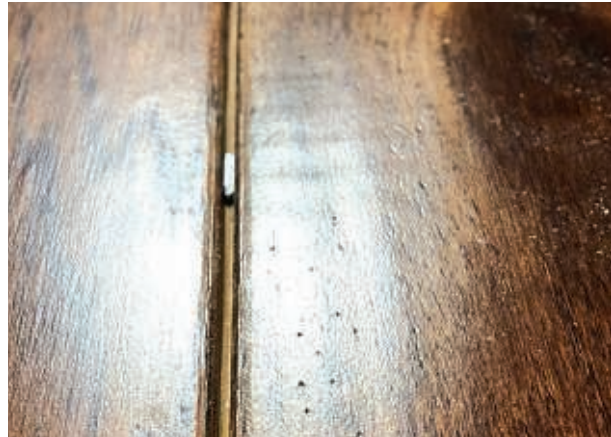
DEFINITION: Gaps between abutting wood floor boards in the installed floor that were not intentionally placed and remain with seasonal fluctuations in moisture and humidity.

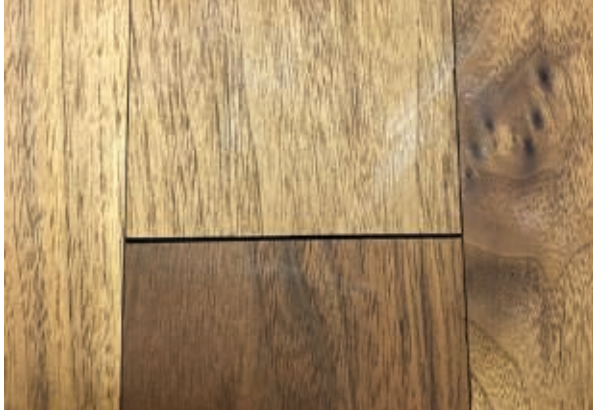
DEFINITION: A separation that occurs on the ends of two abutting wood floor boards.

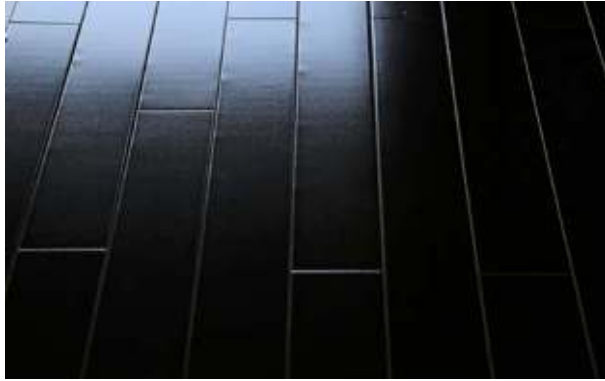
DEFINITION: Dimples or bumps along the nailing surface of the finished flooring, directly related to fastener location and/or installation method.

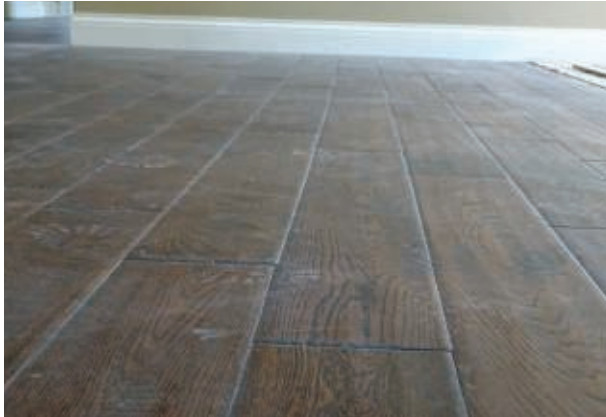
DEFINITION: An installed wood floor appearing bowed or out-of-square within the room in which it is installed. No wood floor installation is perfectly straight, parallel, or perpendicular to walls or fixtures. When the straightness of the installed floor takes away from the overall appearance of the floor within the structure, an aesthetic remedy may be necessary. The performance and structural integrity of the wood floor is not normally affected with any floor that has been installed out-of-square or out-of-a-straight-line.

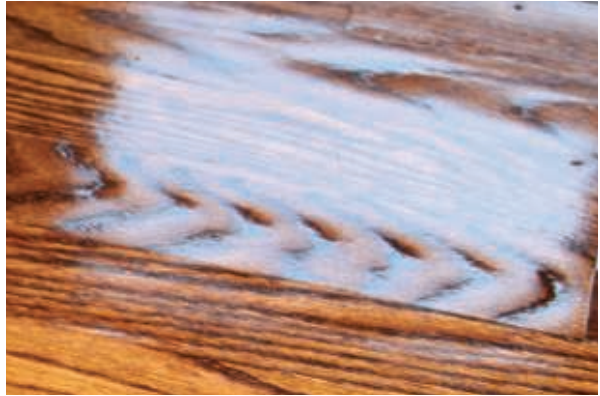
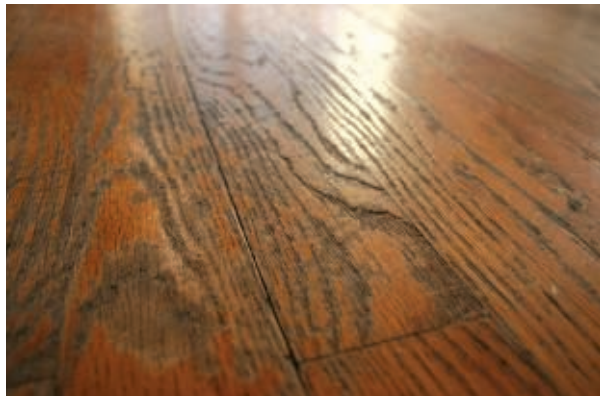
DEFINITION: Undulations in the surface of individual boards or within the wood floor, resulting from softer areas having been worn, hollowed, or sanded to a lower level than harder adjacent areas.

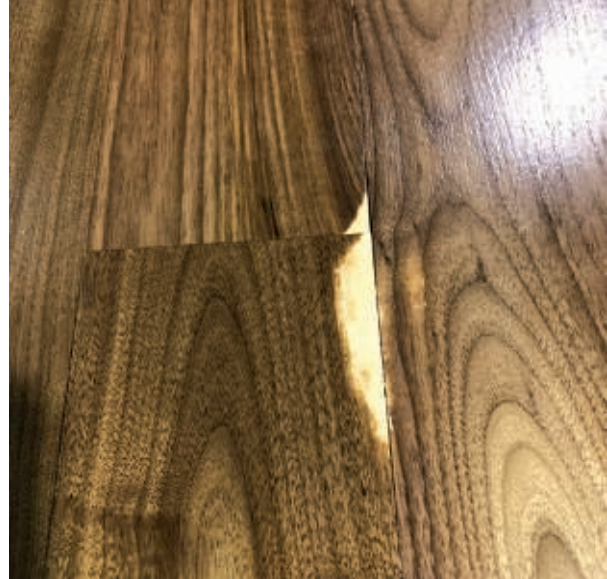
DEFINITION: The top/wear layer veneer (lamina) of engineered flooring has been completely sanded through to the core layer.

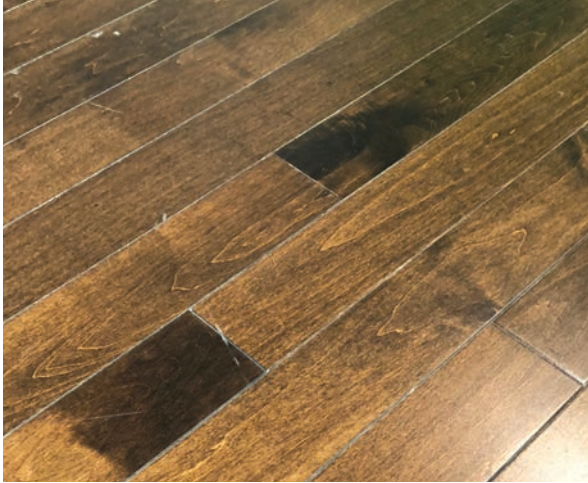
DEFINITION: The appearance of an inconsistent stain or colorant from one area of a finished floor to another. Stained/colored floors should be uniform in color. Color tones may vary from board to board or within individual boards due to natural variances within the wood.

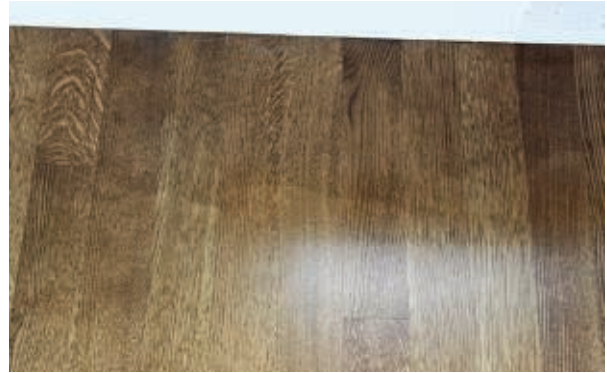
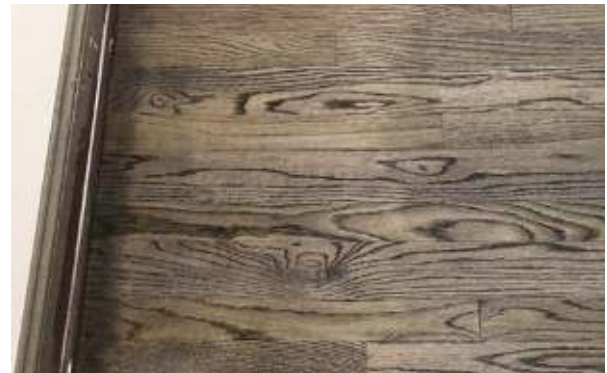
DEFINITION: The edges of the room appear to be a slightly different color than the rest of the room.

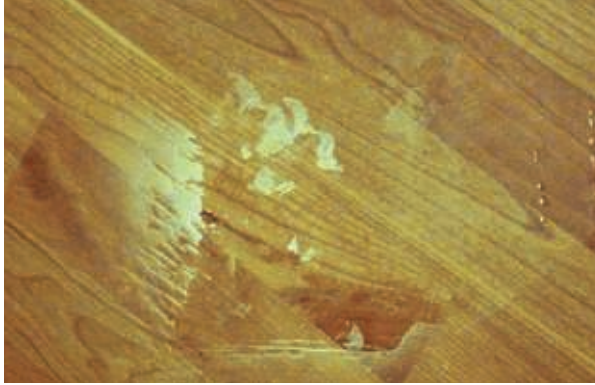
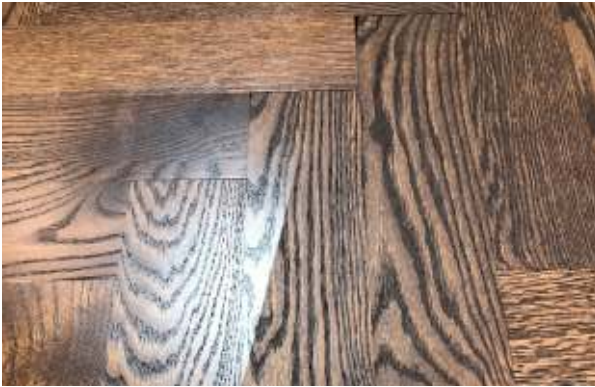
DEFINITION: An exposed area of uncoated wood or the undercoating, when the intention was to coat the entire area.

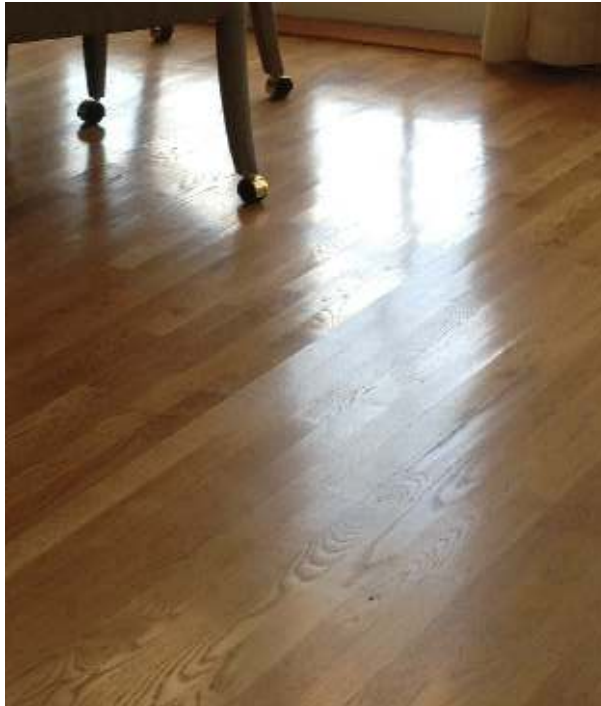
DEFINITION: The sheen or gloss level of the final coat of finish varies from one area of the floor to another. As film-forming finish products decrease in gloss, they increase in amounts of matting agents. Lower sheen products have the most matting agent, and thus, can more-easily manifest uneven sheen levels. Sheen/gloss levels should not be assessed until all final coats have been applied and are fully cured.

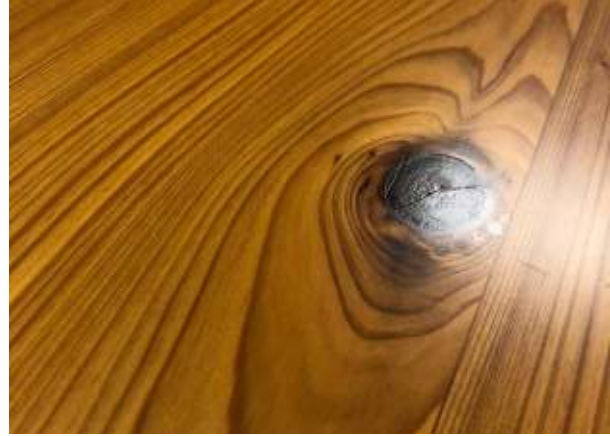
DEFINITION: Wood floor finishes that do not dry, adhere, cure properly, or appear the same on specific areas of a board or individual boards.

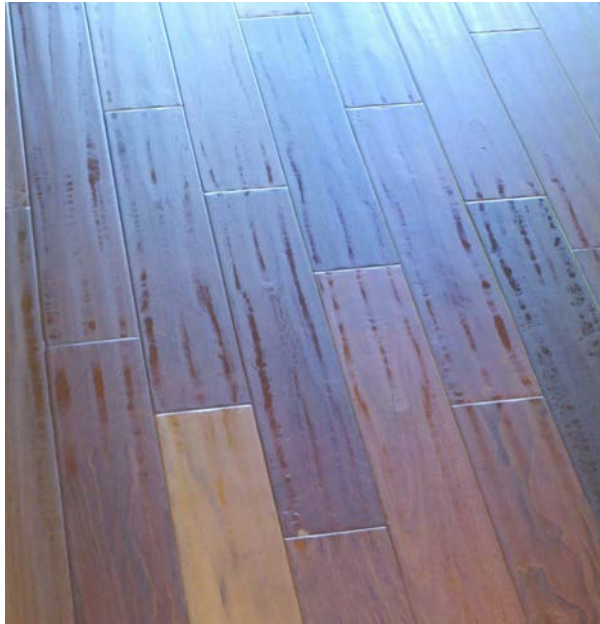
DEFINITION: An unintended white, milky, or cloudy appearance of an otherwise transparent, clear finish.

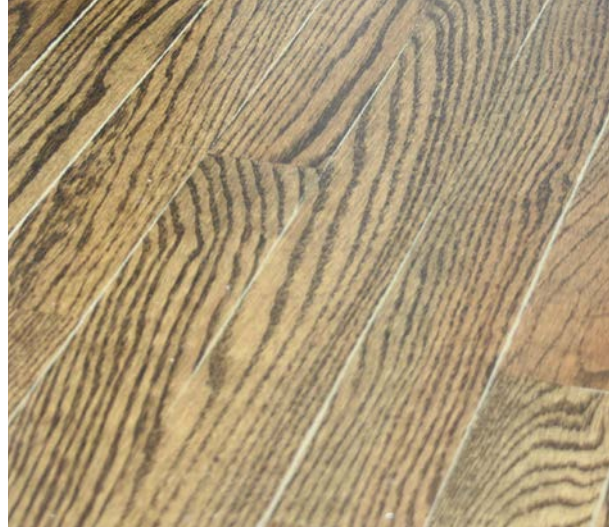
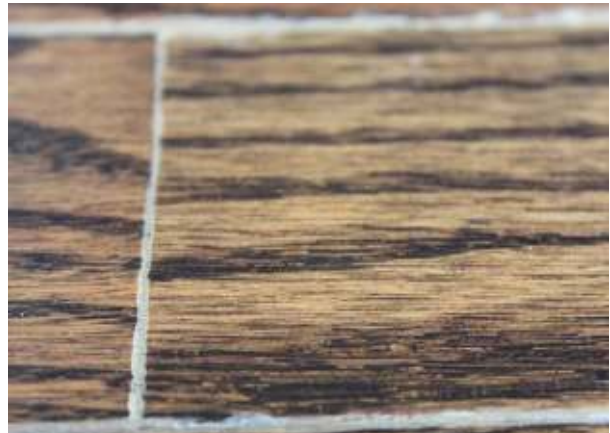
DEFINITION: White lines appear between board edges of site-applied film-finishes.

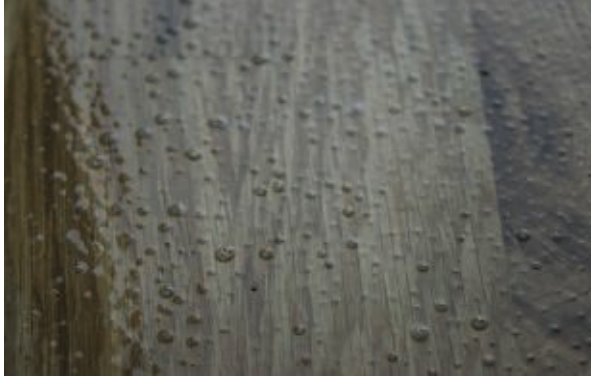
DEFINITION: Raised bumps, or air-filled bubbles visible in the film of the finish. These include both full bubbles and bubbles that have popped.

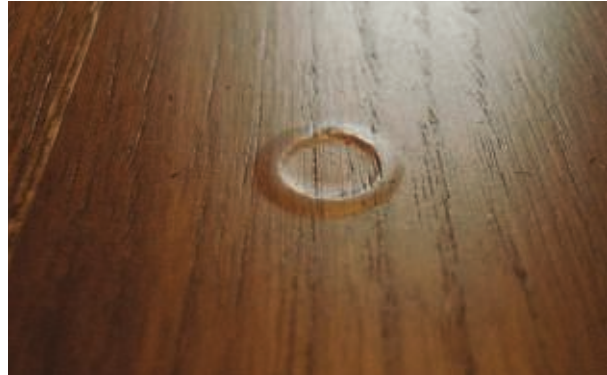
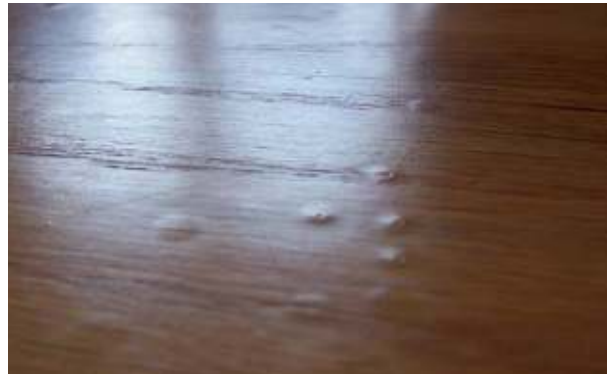
DEFINITION: A visible finish imperfection that manifests by the crawling of wet finish film into a single area or pattern resembling small dimples or bowl-shaped depressions, sometimes accompanied by a particle in the center.

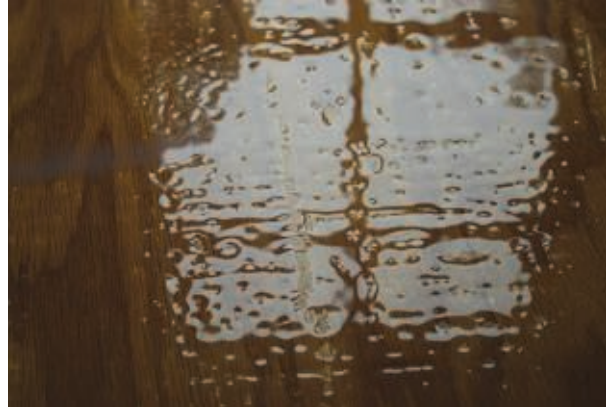
DEFINITION: A visible finish imperfection where the finish film is repelled from areas of the surface, leaving the appearance of thin or uncoated affected areas. May be very long and oval shaped, and may vary in size.

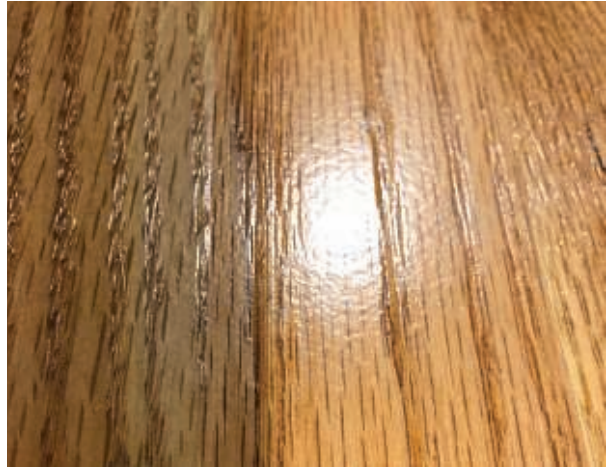
DEFINITION: A visible finish imperfection where the surface of the dry finish film exhibits a flaw that resembles the texture of an orange peel.

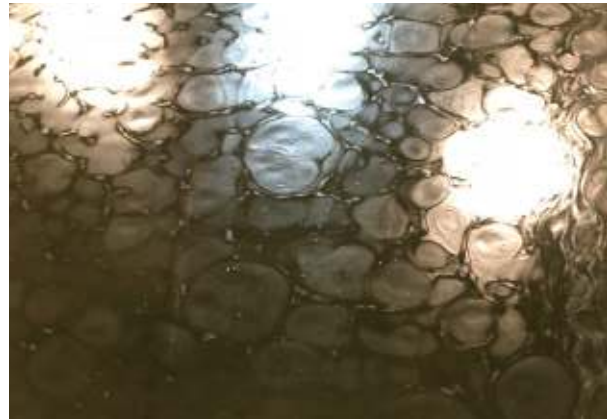
DEFINITION: A visible finish imperfection resembling a pattern in the smooth finish film that resembles a clustering of "cells." They typically appear as less-glossy, often round, curvy, or geometrical (hexagonal, pentagonal) in shape, and may range in size from very small, up to 1". Benard cells are more common with lower sheen or pigmented finishes.

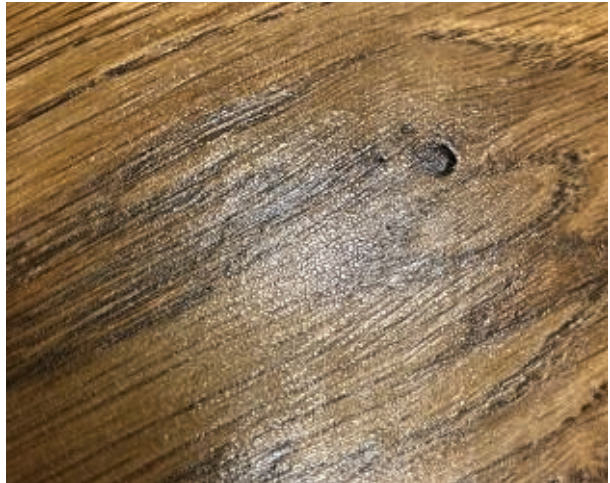
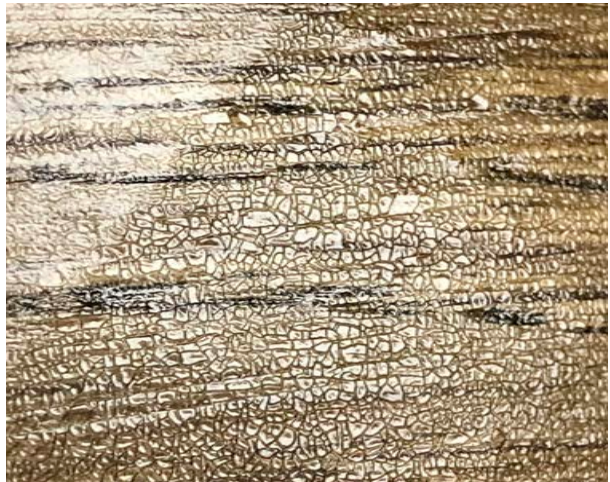
DEFINITION: A visible finish imperfection that appears as a network of very small, fine cracks or fissures in the surface of the finish film, which sometimes resembles the skin of an alligator or crocodile.

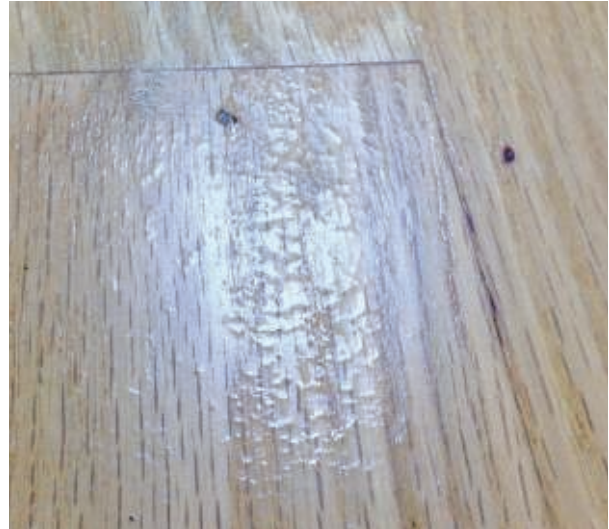
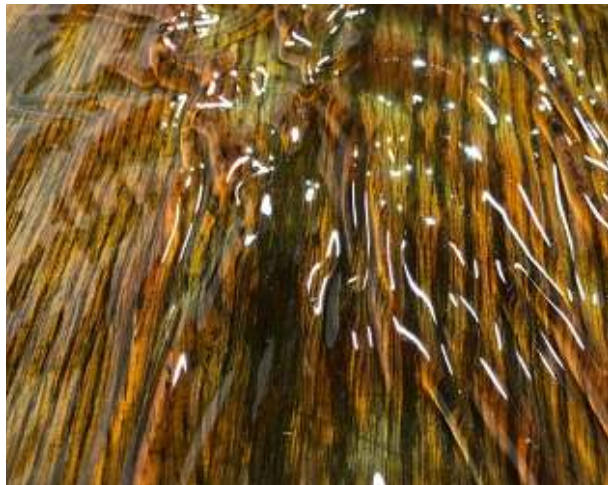
DEFINITION: A visible film-finish imperfection that appears as the skin of a dried prune. Wrinkling may happen with all types of film-finish, but is most common with oil-based urethanes.

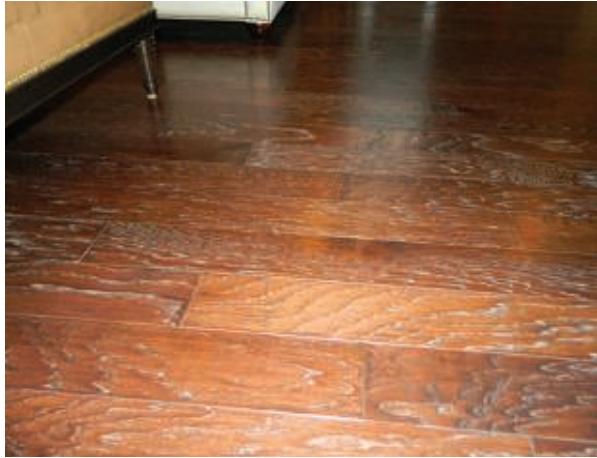
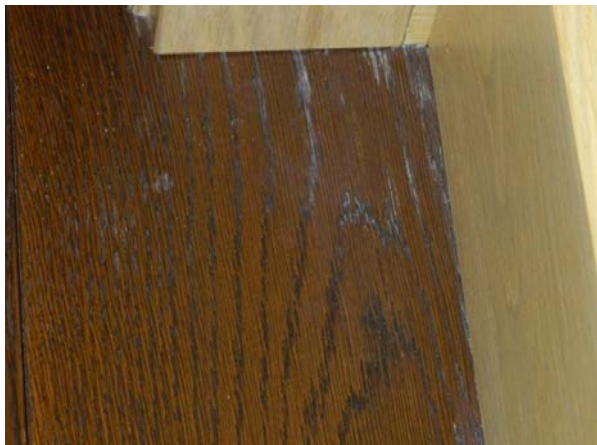
DEFINITION: An accumulation of contaminants in open voids or characters, such as in textured wood, the soft grain/springwood, open knots, splits/checks, etc., on the surface of the installed floor.

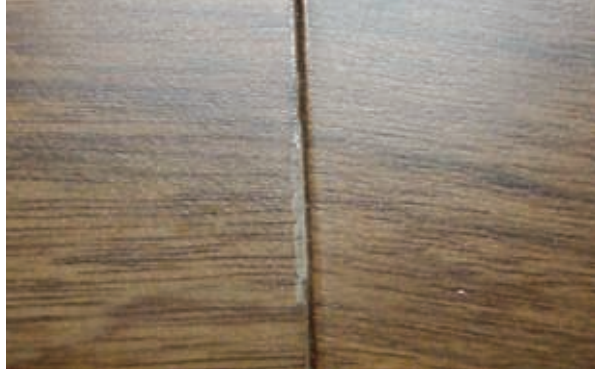
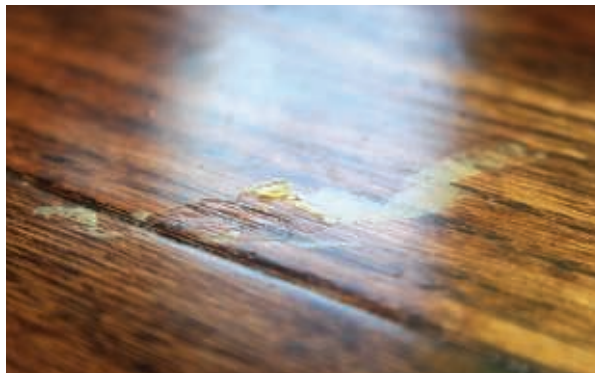
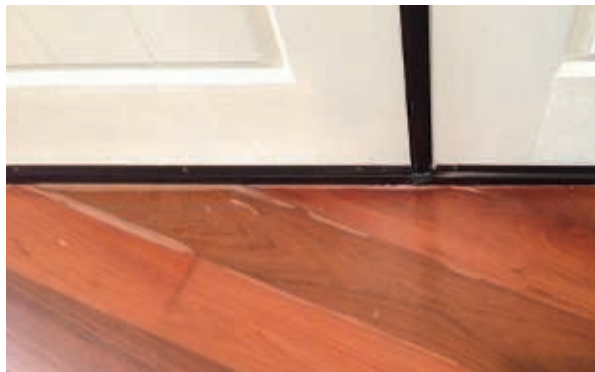
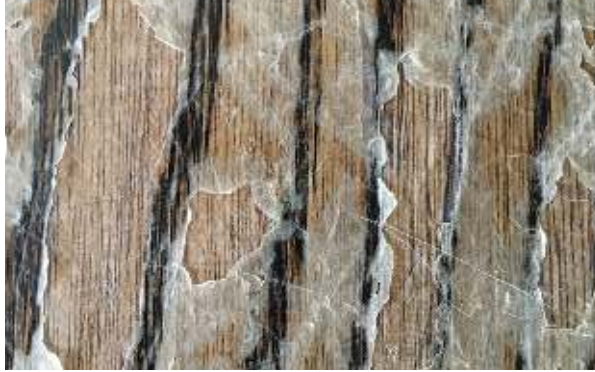
Chipping/Flaking Finish - The condition that occurs when a dried film of finish separates from the previously applied finish in the form of chips or flakes.

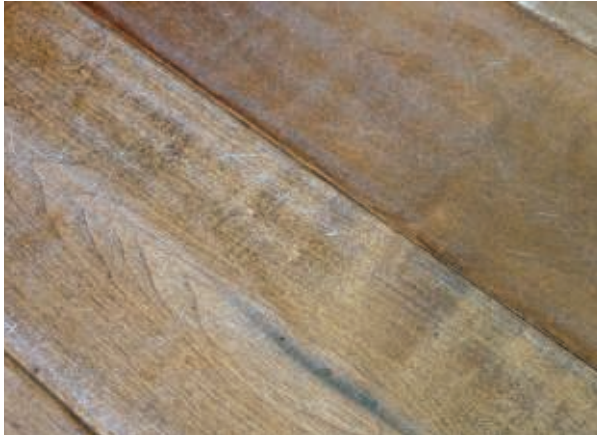
DEFINITION: The performance of the surface coat of finish not meeting expectations.

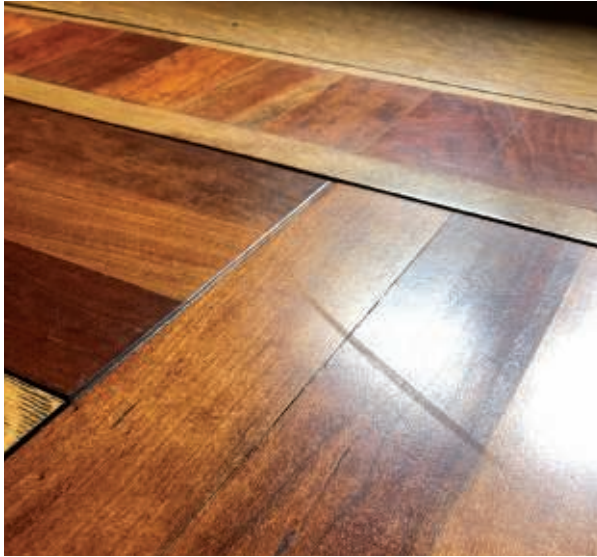
DEFINITION: Marks or abrasions left on a wood floor surface or finish.

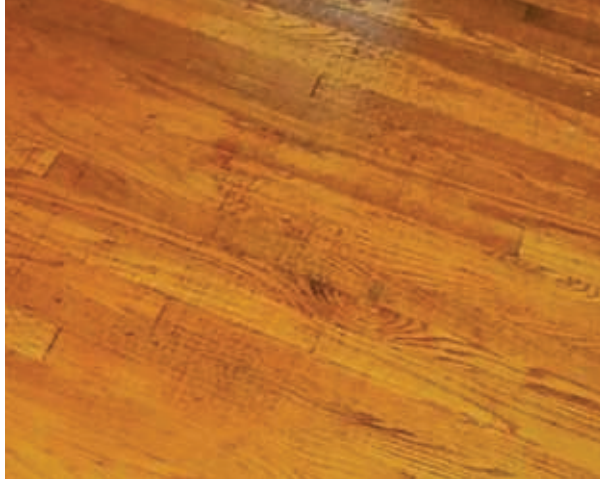
DEFINITION: A shape or pattern imprinted on the face of the board, which resembles an item or object that had been in direct contact with it.
